DECLARATION OF RONDA
LARSON KRAMER IN SUPPORT OF
PLAINTIFF'S MOTION TO SET
BOND

ARBORIST REPORT and TREE RISK ASSESSMENT

For: Save the Davis-Meeker Gary Oak

7637 Old Highway 99, Tumwater, WA. 98501

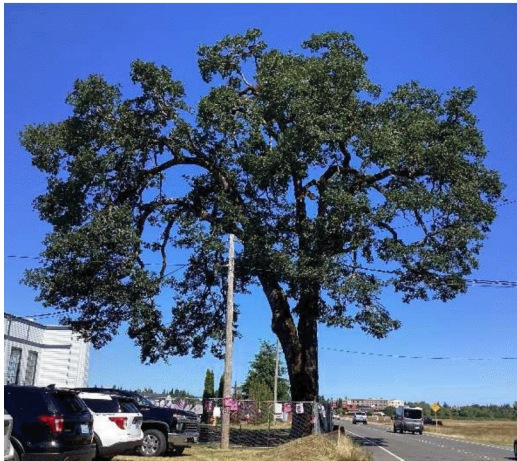
Davis Meeker Oak Tree

The Davis Meeker Gary Oak tree is estimated to be 400 years old. It is a historically significant tree because it is a feature of what once was part of the Oregon Trail—today, living in a growing space next to Old Highway 99 in Tumwater, WA.

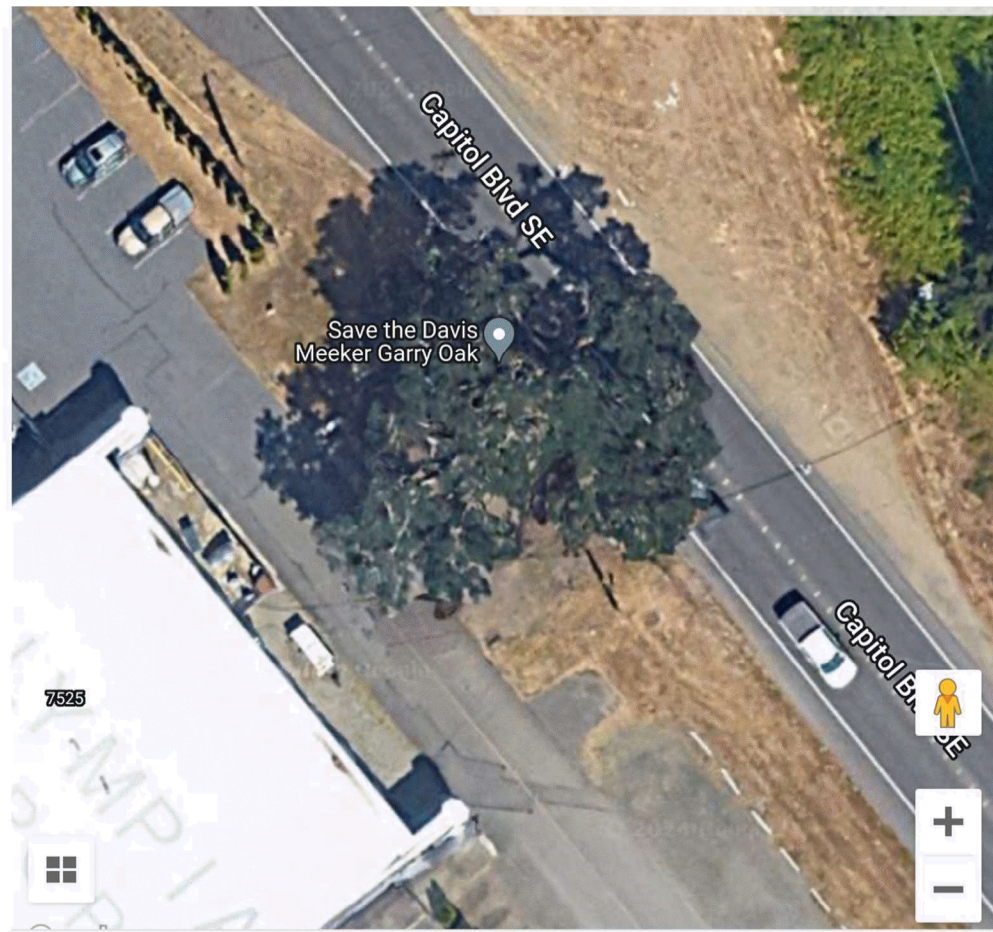
This oak tree lives in compact clay soil and asphalt pavement between a busy highway and an airport service road. Nearby targets that were considered were vehicle and bicycle traffic on the highway. The large airport hangar, the vehicle, bicycle, and pedestrian use of the service roadway, including two parking areas with multiple spaces, and service power lines to the hangar.
