## **Tree Risk Assessment for the Davis-Meeker Oak**

**Date:** February 7, 2025

**Site Address:** 7525 Old Highway 99 SE  
Tumwater, Washington 98501

**Prepared for:** Lisa Parks, City Administrator  
City of Tumwater  
555 Israel Road SW  
Tumwater, WA 98501

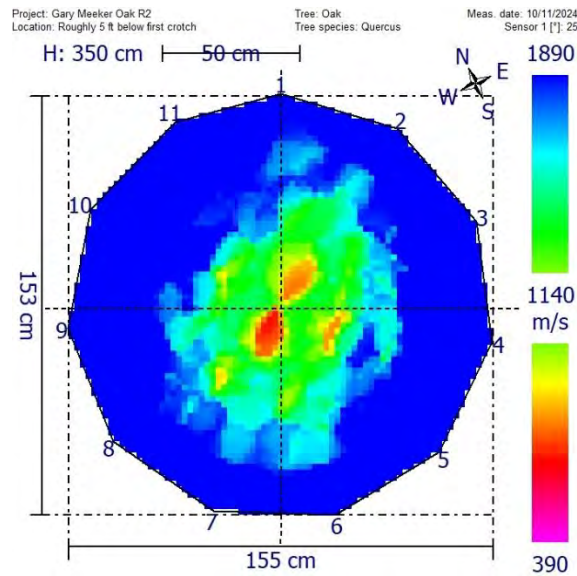
At this level there is a small amount of compromised wood in the center of the stem. The green indicates where the co-dominant inclusion is causing a weak attachment point.

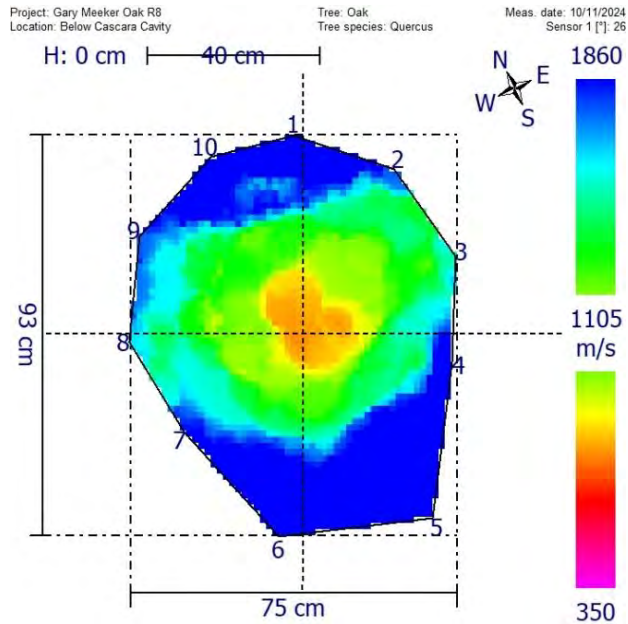
At this level there is less dense wood in the center of the stem. The center yellow spot indicates where the cavity above extends too.

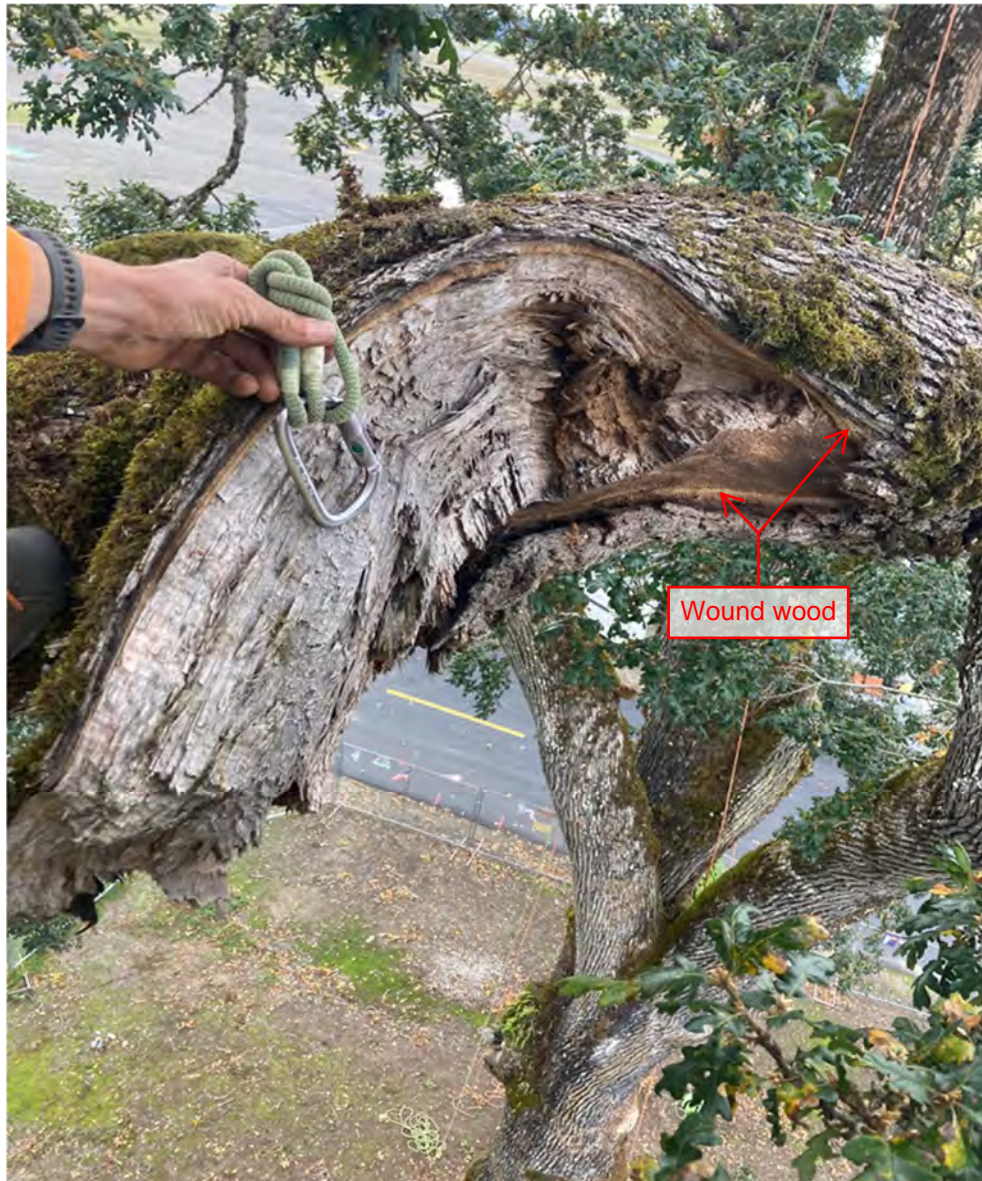
Figure 25 Carabiner used for scale. Note two to three years of wound wood growth around margin of injury.
