**DECLARATION OF DEBBIE SULLIVAN**

# Memo

**To:** Mayor Debbie Sullivan, City of Tumwater  
**From:** Kevin M. McFarland, City of Tumwater Contracted Tree Protection Professional  
**Date:** 5/10/2024  
**Re:** Update to Meeker Oak Tree Risk Report

RE: Meeker Oak Risk Assessment

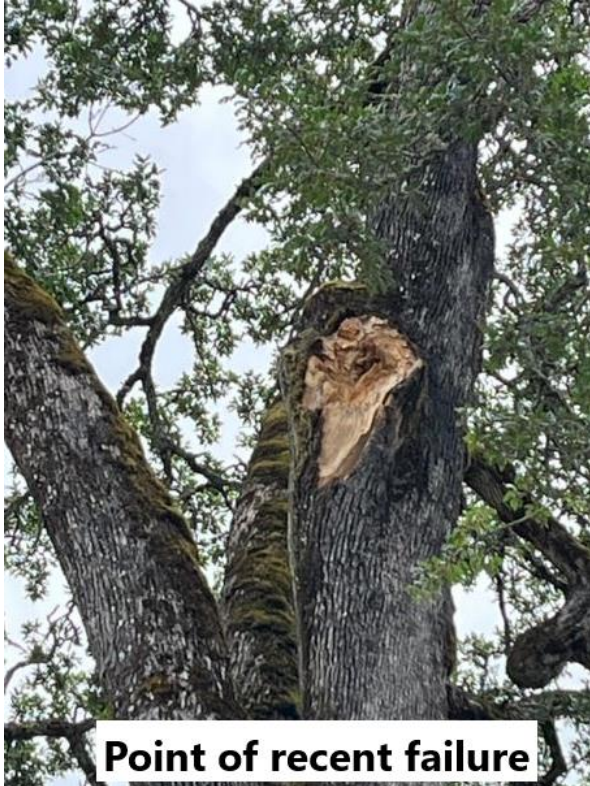
| Species | DBH (in) | Height (ft) | Live Canopy Ratio | Target | Distances to Target | Condition | Comments | Risk Rating |
|---|---|---|---|--|---|---|--|---|
| Oregon White Oak<br><i>Quercus garryana</i> | 66 | 125 | 35 | Hwy 99, south parking, north parking, power-lines, aircraft hangar | 6', 30', 40', 4', 12' | Poor | Recent failure of an 18" scaffold branch on the north side at 50'. Also, a former failure of a 12" scaffold branch on the east side at 65'. There are signs of white rot infection on the upper sides of both points of failure. Failures were likely due to the infection along with the inclusions and end weight. Trunk soundings on the north and northeast sides at the base indicated probable interior decay up to 6'+. An open decay cavity is present within this location. Two core samples extracted from this area at 3' above grade: #1 taken above the cavity revealed 5" of solid wood, #2 revealed 4" of solid wood. A probe inserted into the cavity did not meet any resistance until 2' and the tip was covered in wet, decayed wood. | High |

**Point of recent failure**

Based on my findings and information I have been provided, I am recommending removal.

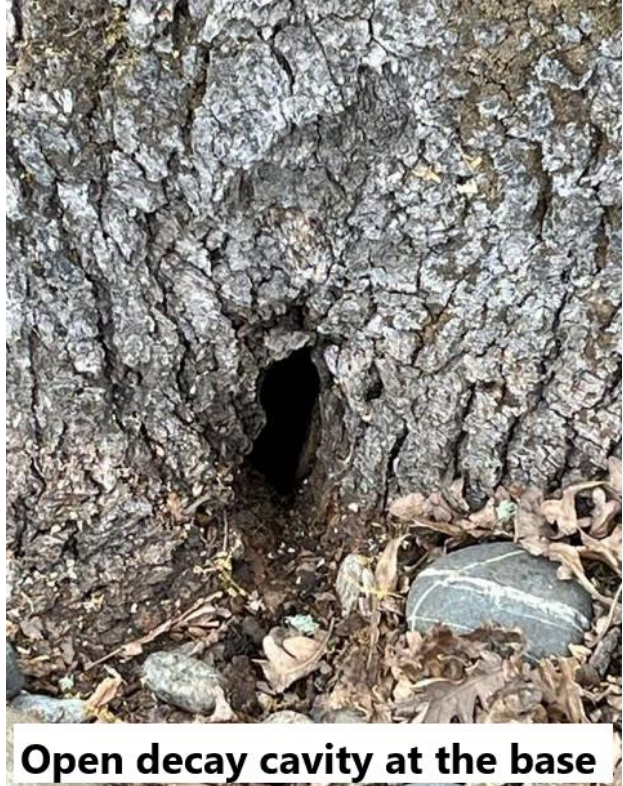
**Open decay cavity at the base**

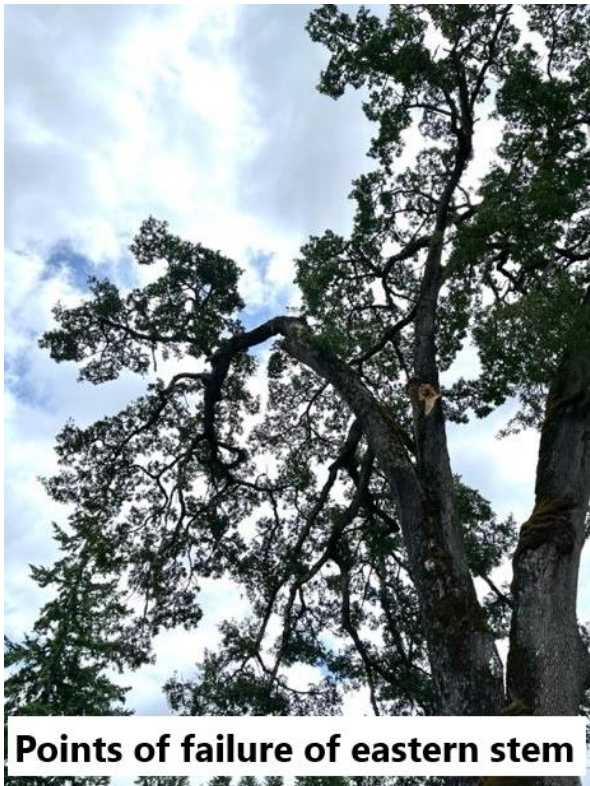
**Points of failure of eastern stem**

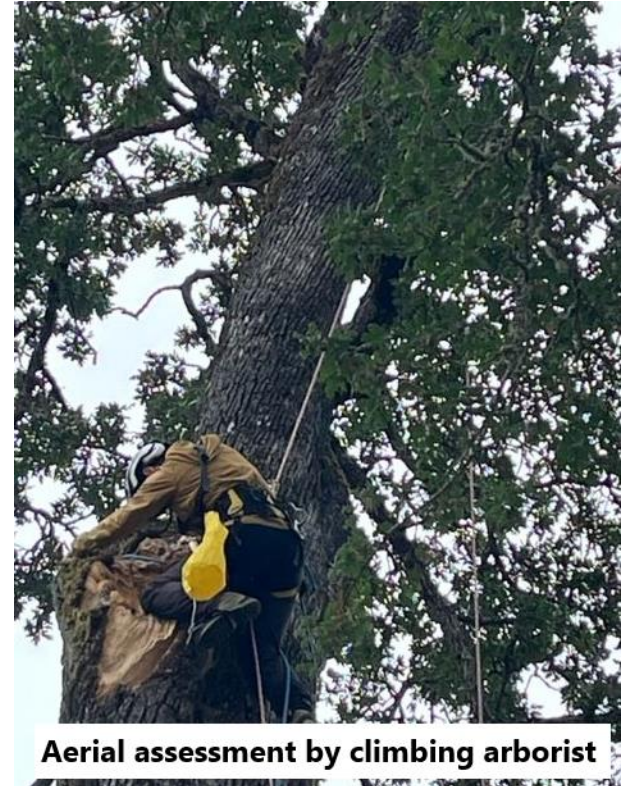
An aerial assessment was conducted by Amanda Hancock (ISA Certified Arborist TX4155AU & TRAQ) with Waxwing Tree Specialists on June 29, 2023. This inspection found extensive white rot decay within the large scaffold that recently experienced failure at the union (see photo). Further examination determined that the main stem's decay column continues upward into the eastern co-dominant stem and large diameter scaffold branches (see attached diagram). The west facing co-dominant stem contains solid healthy interior wood upward into the large scaffold branches overhanging the drive and aircraft hangar.

**Aerial assessment by climbing arborist**

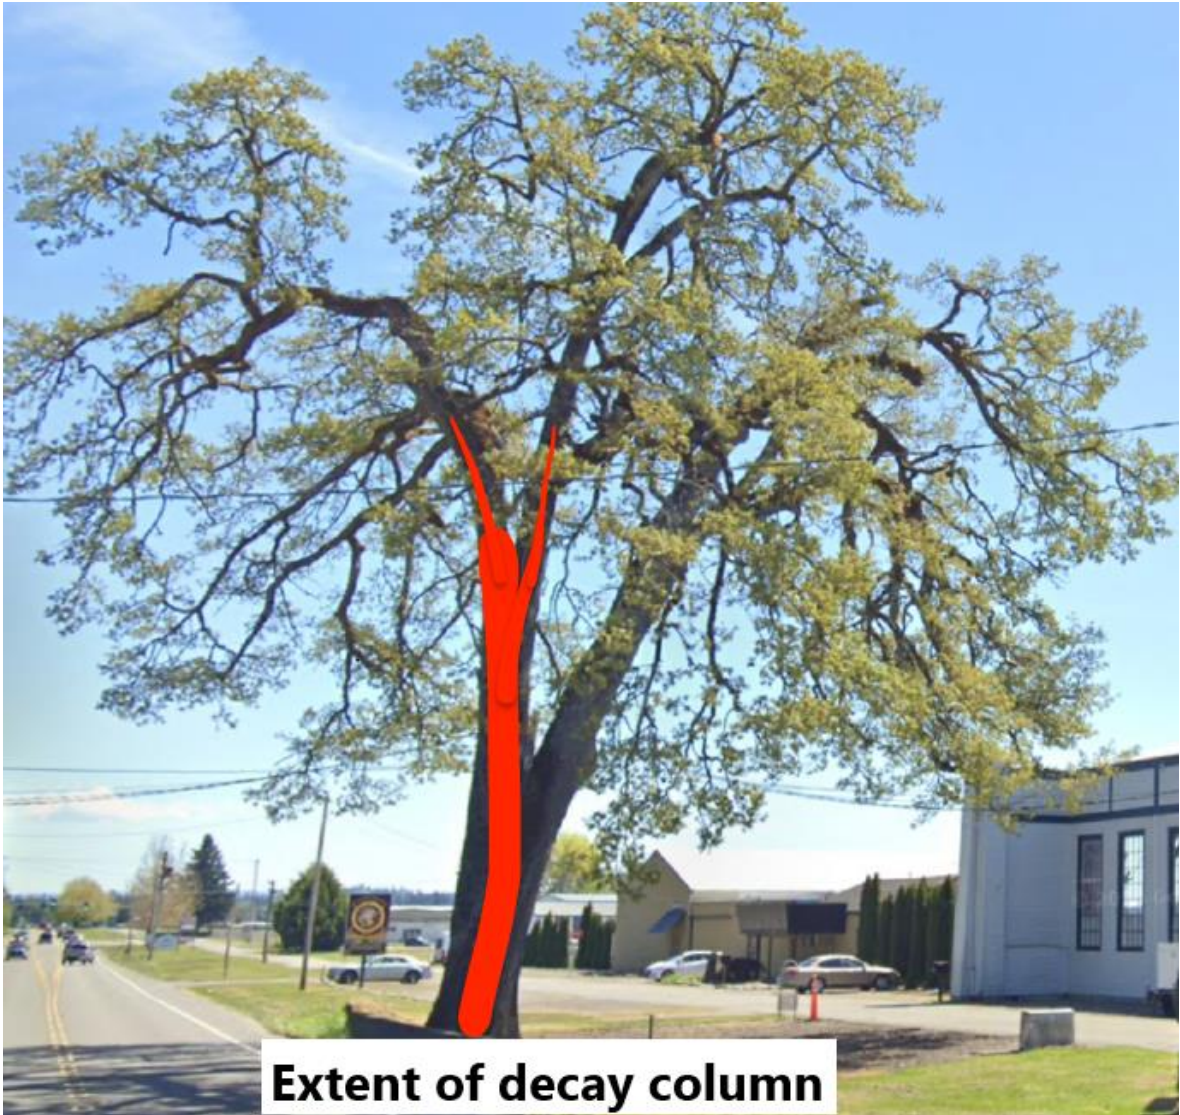
**Extent of decay column**

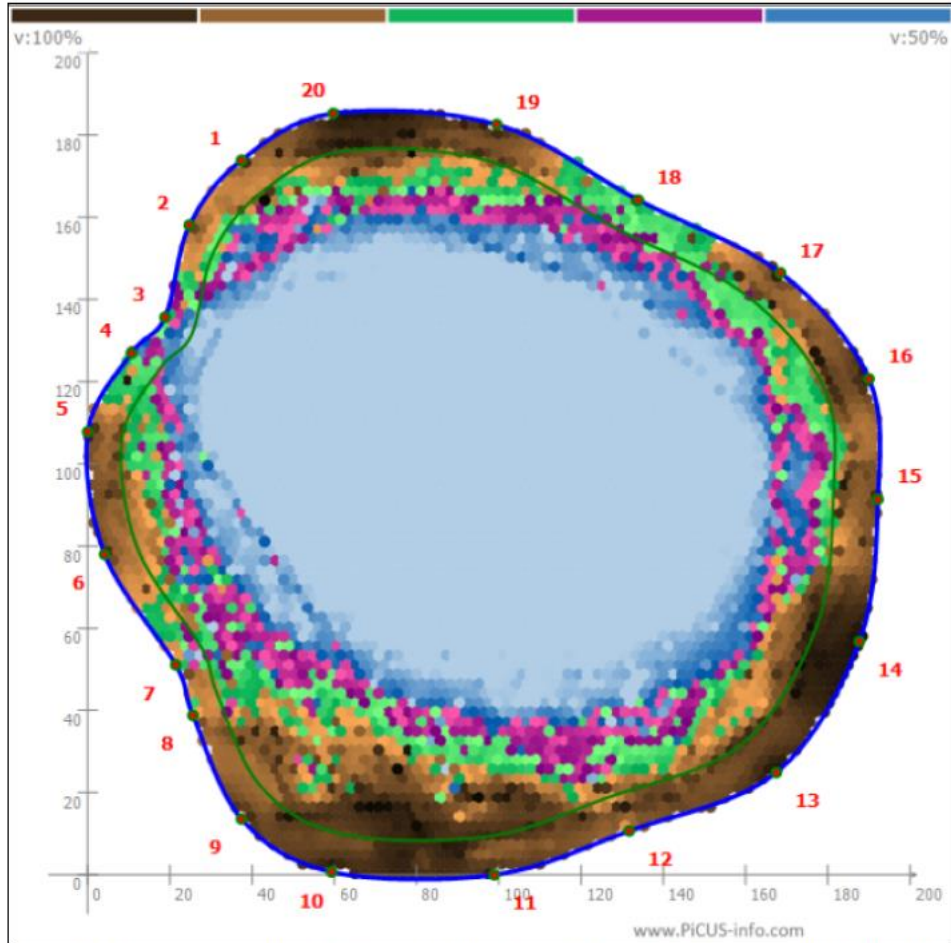
I used a PiCUS sonic tomograph to obtain a tomogram 50 centimeters above the tree base. I selected this height based on soundings of the trunk which indicated the most extensive decay was located low in the trunk. I used the PiCUS Q74 program to analyze the data and obtain a rough estimate of the remaining sound wood shell wall required to maintain tree stability, indicated by the green line in Figure 1 in Appendix A.

The tomogram indicates there is slightly more sound wood than is required to support the tree. However, due to the extent of the decay and thin shell wall around measuring points 3, 4, and 18 it is my opinion that this tree should be managed as a veteran tree and have retrenchment pruning performed to reduce the tree height and spread by approximately 15 feet. Reducing the tree height and spread will result in lowered wind loads acting on the trunk and branch unions resulting in a lower likelihood of failure.

**Figure 1.** Sonic tomogram of the subject tree. North is located at measuring point 1, and the side of the tree towards the highway is along measuring points 17, 18, and 19. The blue areas indicate decay or a decay cavity, and the brown areas indicate sound wood. The purple and green areas indicate early or spreading decay. The green line is the calculated shell wall of sound wood required for the tree to remain stable.

If this tree is retained, it should be reassessed with sonic tomography in five years to determine if the decay is continuing to spread and what the remaining shell wall is at that time. Additionally, 4 to 6 inches of wood chip mulch should be added within the dripline of the tree to improve soil conditions. The wood chip mulch should be kept 12 inches from the base of the tree.

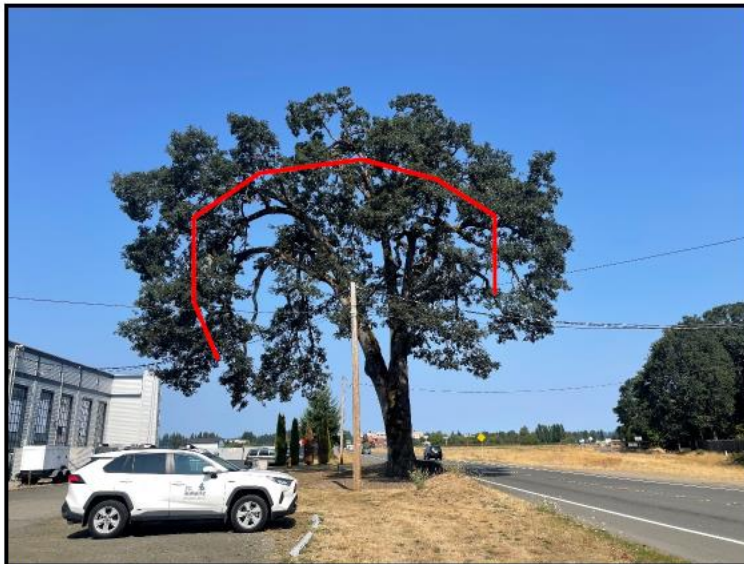
**Photograph 2.** The crown of the subject tree viewed from the southeast. The red line indicates approximately 15 feet of crown reduction.
