CITY OF
TUMWATER

**HISTORIC PRESERVATION COMMISSION
MEETING AGENDA**

**Thursday, March 21, 2024
6:30 PM**

Staff requests that the Commission consider and approve a recommendation to the Tumwater City Council for de-listing the Davis/Meeker Oak from the City's Historic Register.

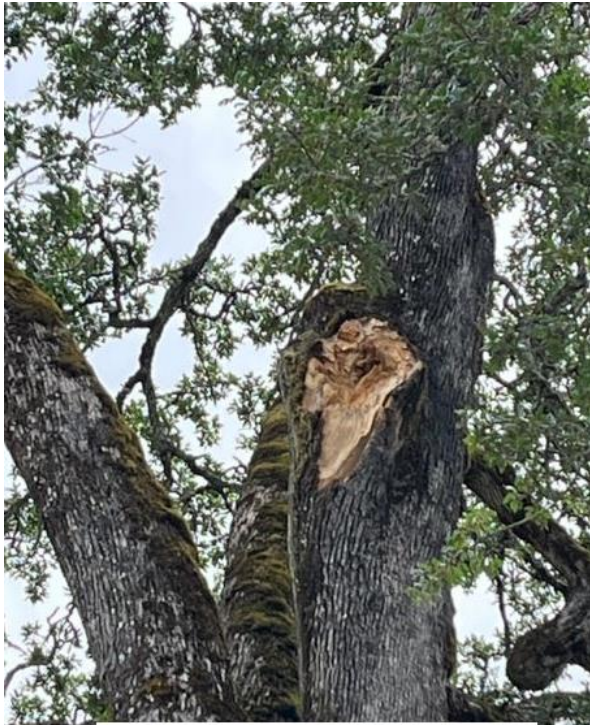
Upon your request, a thorough evaluation of the Meeker Oak located at the Olympia Regional Airport has been conducted. This tree has become of concern due to the recent failure of a two large diameter scaffold branches on the north side. Per your direction, this evaluation has included a risk assessment by myself, an aerial assessment by a climbing certified arborist and a sonic tomography by Tree Solutions Inc, all conducted during the months of June -August of this year. The purpose of this report is to present the findings and offer my recommendations based on those findings to the City of Tumwater.

Point of recent failure

Based on my findings and information I have been provided, I am recommending removal.

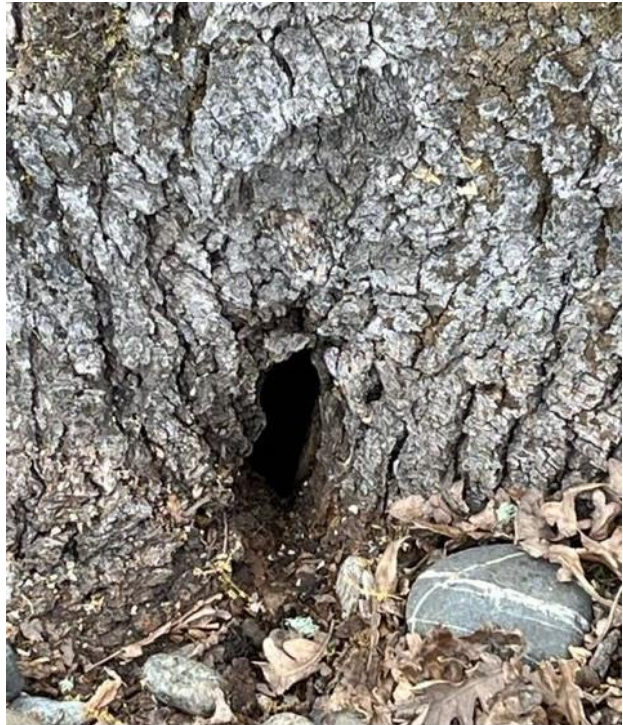
Open decay cavity at the base

Response growth
Main concern(s) Suspect root collar and flare decay

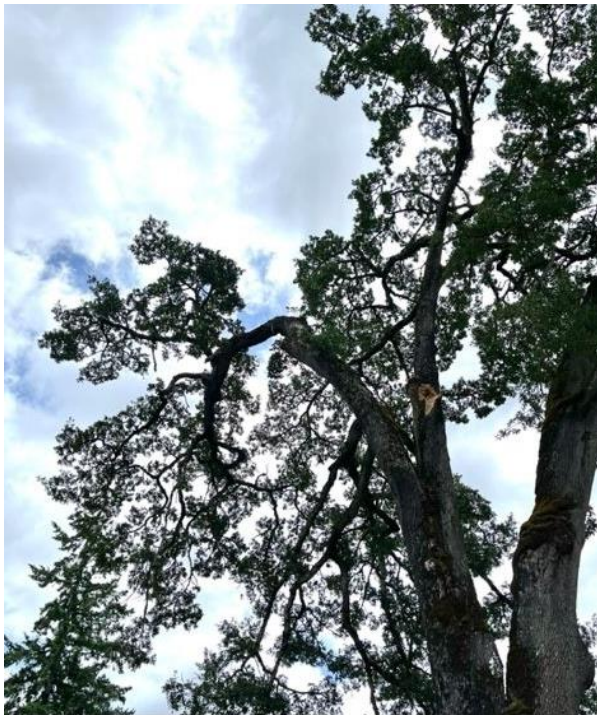
Points of failure of eastern stem

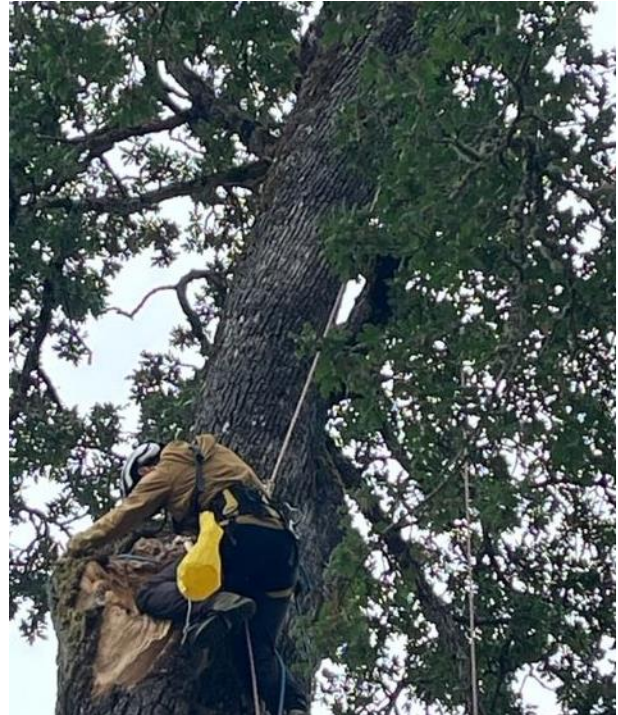
An aerial assessment was conducted by Amanda Hancock (ISA Certified Arborist TX4155AU & TRAQ) with Waxwing Tree Specialists on June 29, 2023. This inspection found extensive white rot decay within the large scaffold that recently experienced failure at the union (see photo). Further examination determined that the main stem's decay column continues upward into the eastern co-dominant stem and large diameter scaffold branches (see attached diagram). The west facing co-dominant stem contains solid healthy interior wood upward into the large scaffold branches overhanging the drive and aircraft hangar.

Aerial assessment by climbing arborist

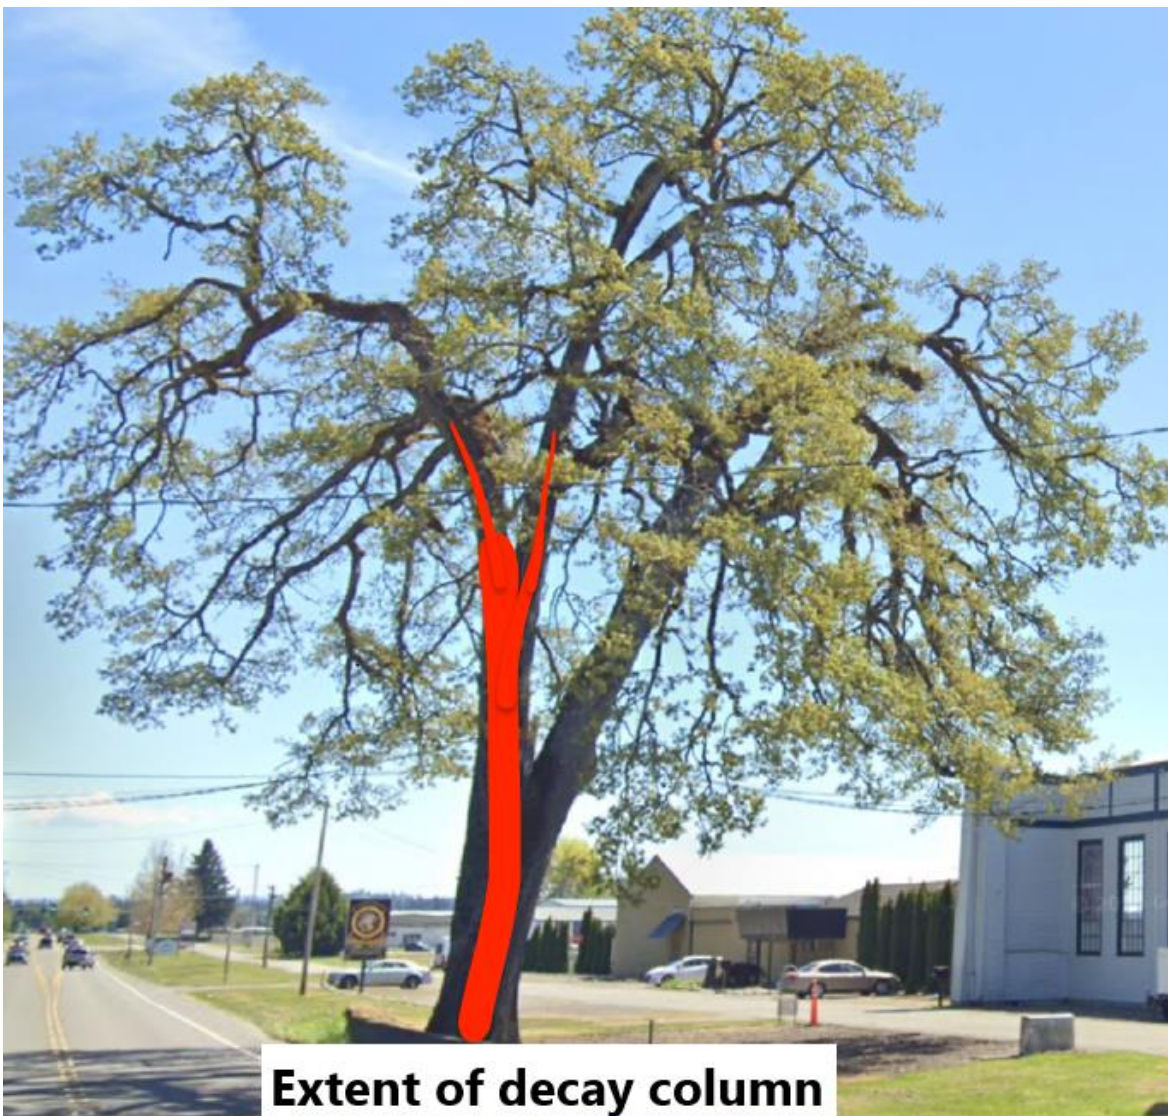
Extent of decay column

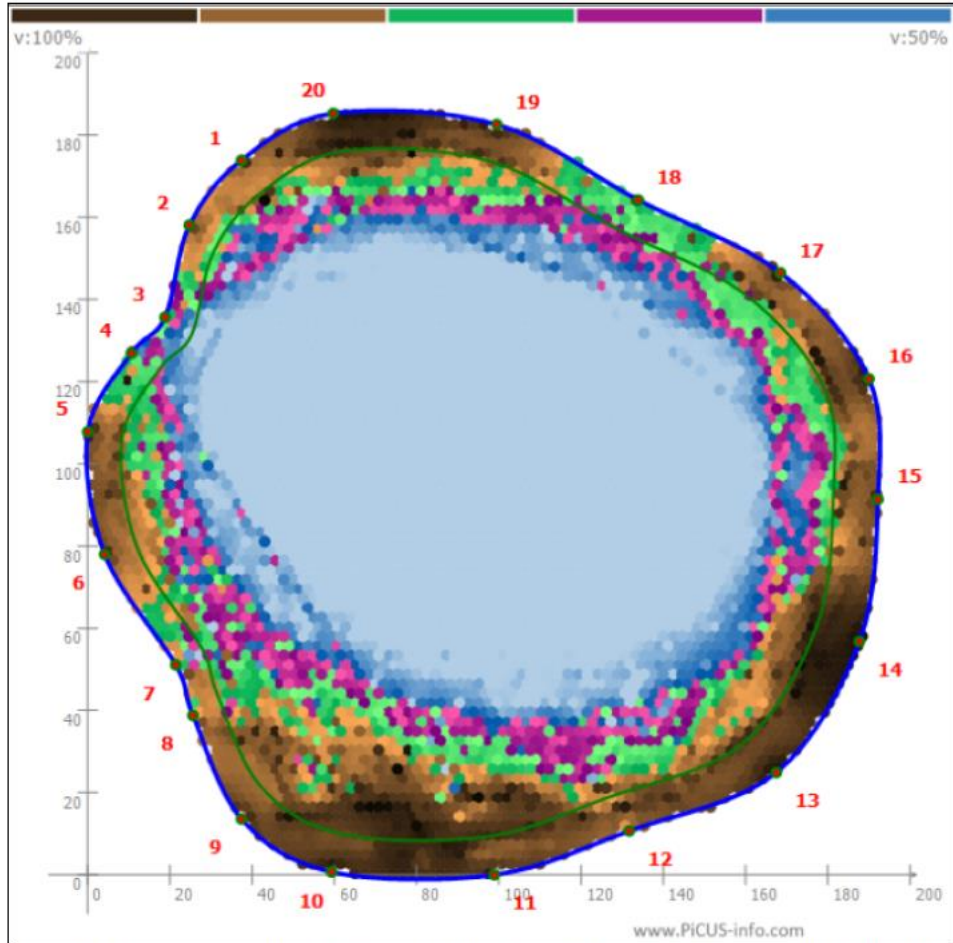
I used a PiCUS sonic tomograph to obtain a tomogram 50 centimeters above the tree base. I selected this height based on soundings of the trunk which indicated the most extensive decay was located low in the trunk. I used the PiCUS Q74 program to analyze the data and obtain a rough estimate of the remaining sound wood shell wall required to maintain tree stability, indicated by the green line in Figure 1 in Appendix A.

The tomogram indicates there is slightly more sound wood than is required to support the tree. However, due to the extent of the decay and thin shell wall around measuring points 3, 4, and 18 it is my opinion that this tree should be managed as a veteran tree and have retrenchment pruning performed to reduce the tree height and spread by approximately 15 feet. Reducing the tree height and spread will result in lowered wind loads acting on the trunk and branch unions resulting in a lower likelihood of failure.

Figure 1. Sonic tomogram of the subject tree. North is located at measuring point 1, and the side of the tree towards the highway is along measuring points 17, 18, and 19. The blue areas indicate decay or a decay cavity, and the brown areas indicate sound wood. The purple and green areas indicate early or spreading decay. The green line is the calculated shell wall of sound wood required for the tree to remain stable.

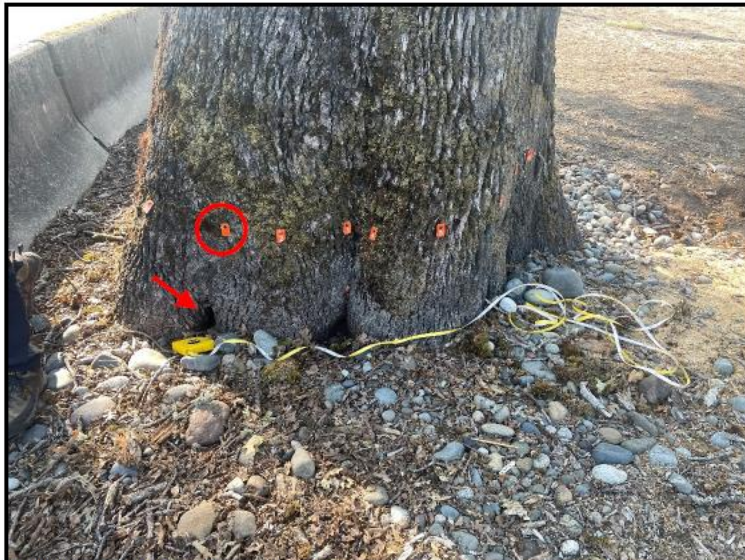
Photograph 1. Measuring point 1 is circled in red. An opening into the decay cavity is indicated by the red arrow.

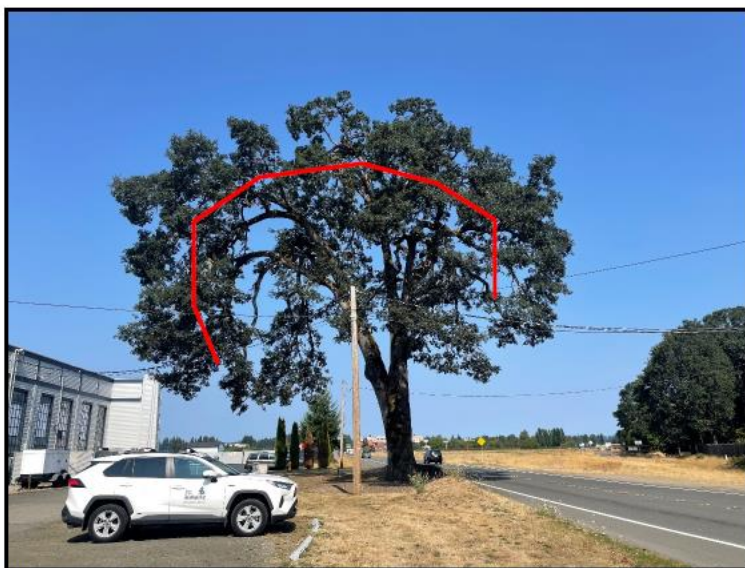
Photograph 2. The crown of the subject tree viewed from the southeast. The red line indicates approximately 15 feet of crown reduction.
