## ARBORIST REPORT and TREE RISK ASSESSMENT

For: Save the Davis-Meeker Gary Oak

7637 Old Highway 99, Tumwater, WA. 98501

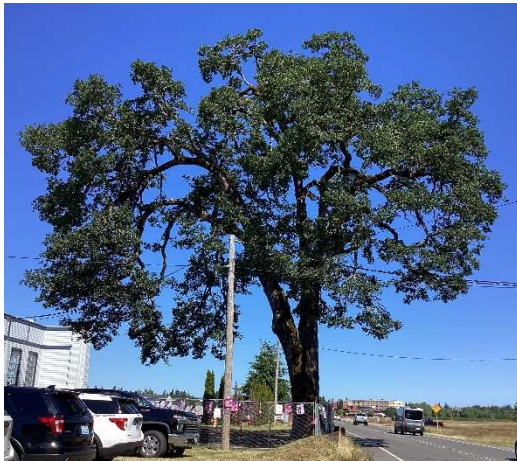
*Davis Meeker Oak Tree*

The Davis Meeker Gary Oak tree is estimated to be 400 years old. It is a historically significant tree because it is a feature of what once was part of the Oregon Trail—today, living in a growing space next to Old Highway 99 in Tumwater, WA.

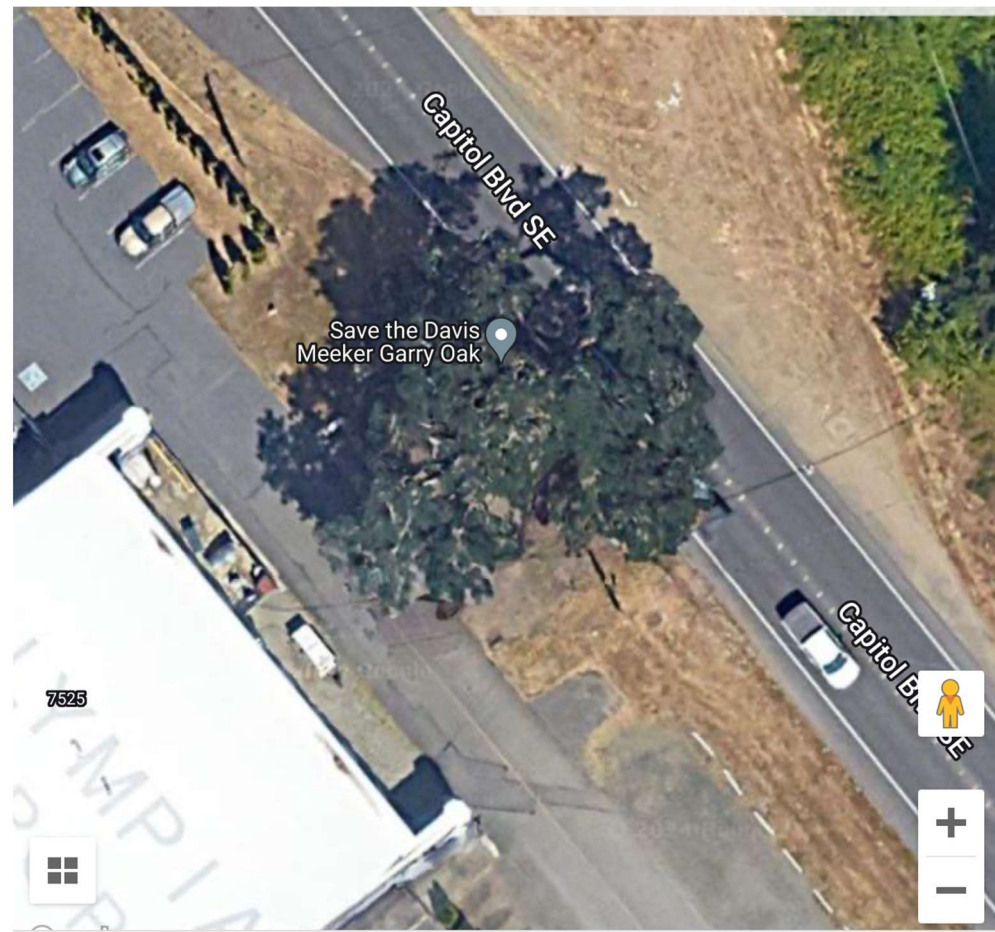
This oak tree lives in compact clay soil and asphalt pavement between a busy highway and an airport service road. Nearby targets that were considered were vehicle and bicycle traffic on the highway. The large airport hangar, the vehicle, bicycle, and pedestrian use of the service roadway, including two parking areas with multiple spaces, and service power lines to the hangar.
