DECLARATION OF RONDA
LARSON KRAMER IN SUPPORT OF
PLAINTIFF'S MOTION TO SET
BOND

ARBORIST REPORT and TREE RISK ASSESSMENT

For: Save the Davis-Meeker Gary Oak

7637 Old Highway 99, Tumwater, WA. 98501

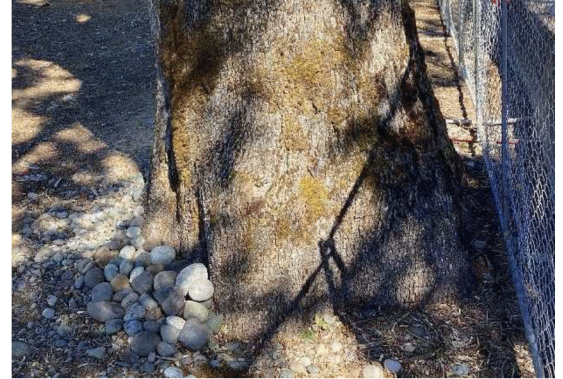
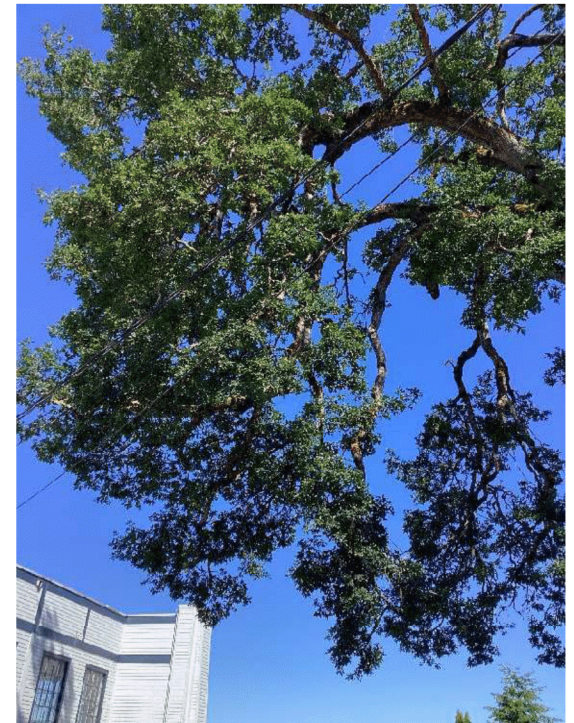
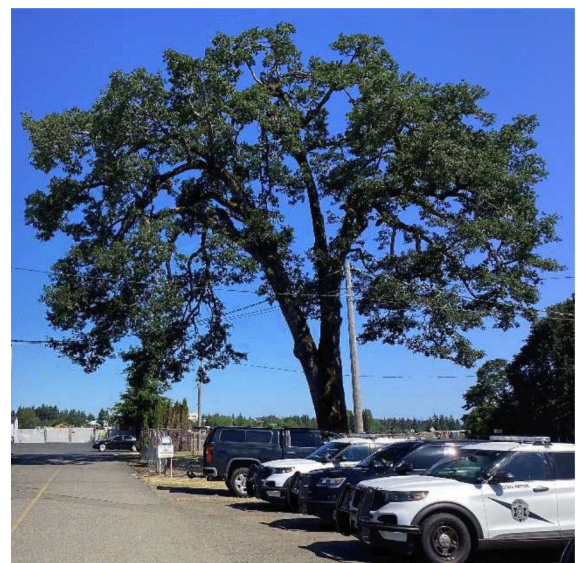
On my visit, I observed nesting birds. The nest is in a cavity roughly halfway up one of the main stems, which is a good indicator of the presence of decay.

The pre-mitigation risk rating per the basic risk assessment is **moderate**. My observations and previous arborist evaluations have noted decay is present in at least parts of the lower 2/3 of the woody portions of the tree. That decay is the main condition of concern in all the reports. Determining the extent of decay in the upper woody parts is difficult. Before applying the recommended mitigation efforts, I highly recommend an additional aerial/climbing inspection by an arborist familiar with ancient oak trees—specifically White Oaks. One such arborist I recommend, who has over 40 years of experience and is still climbing and working on big old Oaks, is Casey P. Roland of Roland Tree Care in Medford, Oregon. That inspection may change the risk rating and would likely provide information to help choose a mitigation option better. An aerial drone inspection would not be sufficient.

3. Remove all the rocks up against or touching the root crown. This will allow a critical and vulnerable area where woody roots join the stem to completely dry out and not hold moisture, making it easier for pathogens to enter.

4. Selective pruning to remove deadwood greater than 1" in diameter and any limbs in active failure. This action alone will move one part of the risk rating (from Matrix 2) from **moderate to low**.

5. Selective pruning for weight reduction in the lower 2/3 of large scaffolding branches. No cuts should be over 3" in diameter and, when possible, made from parts beneath the larger limbs. No pruning or topping of any "green" limbs in the top 1/3 of the tree crown should be made. No more than 10% to 15% of the healthy "green" limbs in the entire crown should be removed during the pruning operation. This will reduce some weight in the decayed or over-extended limbs. All pruning should be done by or under the supervision of an ISA Certified Arborist to ANSI Z-133 requirements and industry best practices.

6. Install a support system, such as a dynamic cable system, per ANSI Z-133 Safety Requirements and ISA best practices and standards. This action will reduce load pressure on codominant and decayed limbs, moving the other risk rating (from Matrix 2) from **moderate to low** and ultimately reducing this tree's overall residual risk rating to **low**.

** The recommended aerial inspection can determine the cable system's feasibility, type, and location.*
7. Restrict pedestrian access beneath the tree and move parking away from the dripline to 1.5 times the tree's height or as far as possible. This will eliminate or reduce the target occupancy rate.

Monitor and inspect the tree at least every two years. Prune as needed. Inspect and adjust the cable system at least every three years. Maintain wood chip mulch in the root zone.
