## **Tree Risk Assessment for the Davis-Meeker Oak**

**Date:** February 7, 2025

**Site Address:** 7525 Old Highway 99 SE  
Tumwater, Washington 98501

**Prepared for:** Lisa Parks, City Administrator  
City of Tumwater  
555 Israel Road SW  
Tumwater, WA 98501

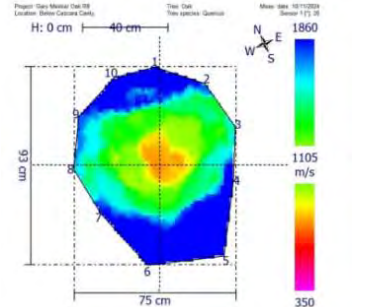
Reading No.	Height	Location Description	Tomography Reading	Narrative Results
8	1381 cm/ 45.3 ft	Stem 1, below kestrel nest, above 2023 failure

<p>At this level there is less dense wood in the center of the stem. The center yellow spot indicates where the cavity above extends too.</p> <p>At this level there is between 6% and 19% strength loss. This is minimal strength loss.</p>
7	1036 cm/ 33 ft	Stem 1, above 2 <sup>nd</sup> codominant stem.

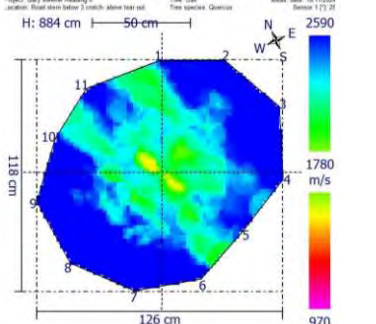
<p>At this level there is likely included bark within the center of the stem, where the codominant stems connect.</p> <p>At this level there is between 2% and 8% strength loss. This is minimal strength loss.</p>

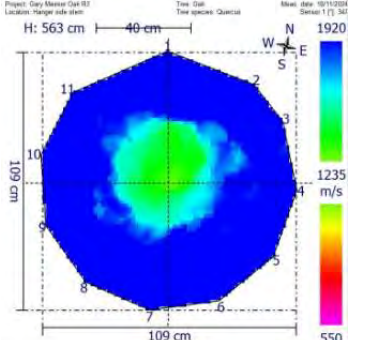
<p>At this level there is no sign of compromised wood.</p> <p>At this level there is between 1% and 2% strength loss. This is minimal strength loss.</p>
<p>3</p>	<p>563 cm/ 18.5 ft</p>	<p>Stem 2, above 1<sup>st</sup> codominant union.</p>

<p>At this level there is no sign of compromised wood.</p> <p>At this level there is between 1% and 2% strength loss. This is minimal strength loss.</p>

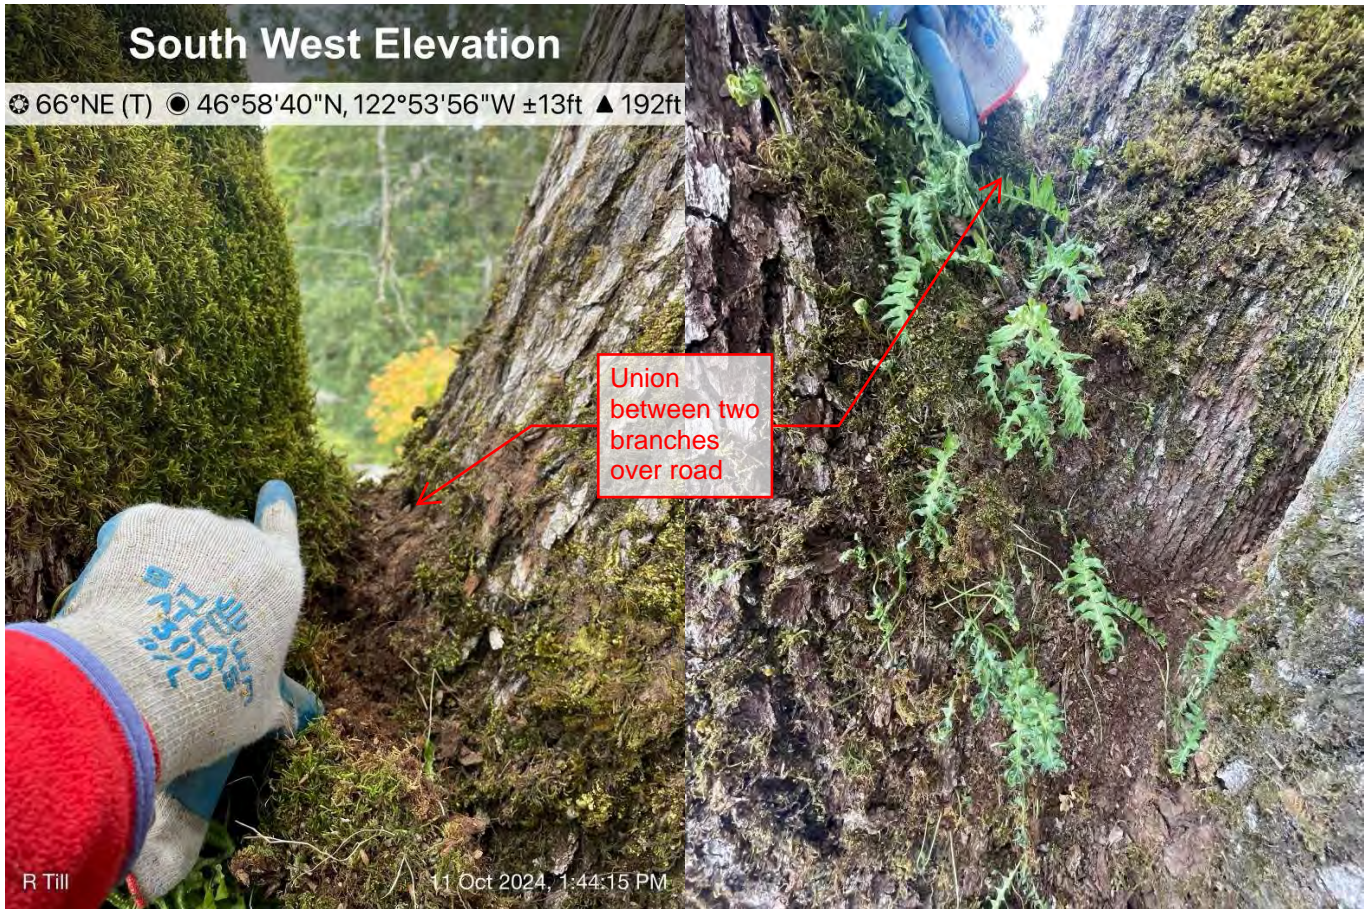
Figures 7 and 8 Southwest view of attachment between two secondary stems extending over the road. Exterior signs indicate a sound union.

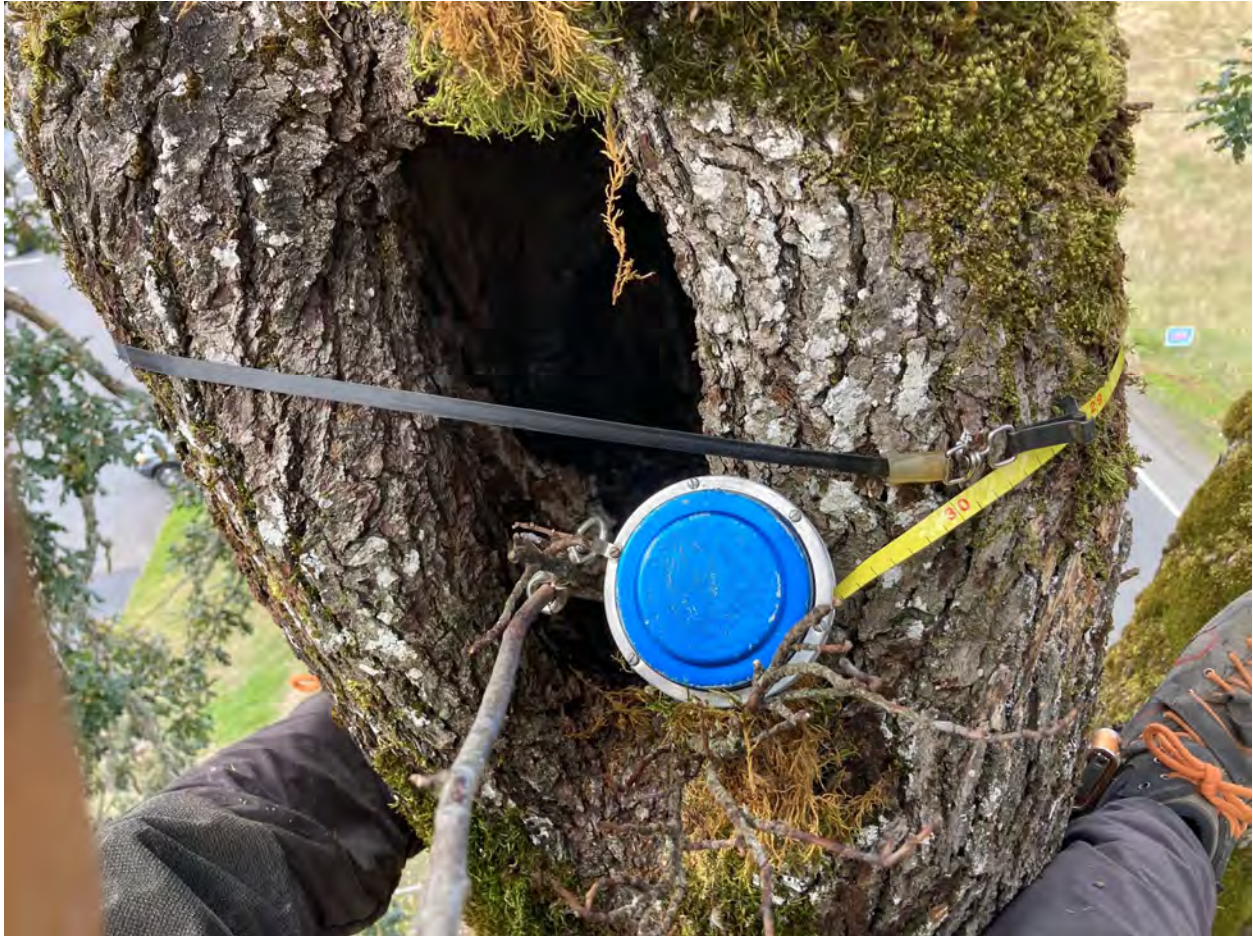
Figure 22 Diameter measurement of approximately 30 inches.
