## ARBORIST REPORT and TREE RISK ASSESSMENT

For: Save the Davis-Meeker Gary Oak

7637 Old Highway 99, Tumwater, WA. 98501

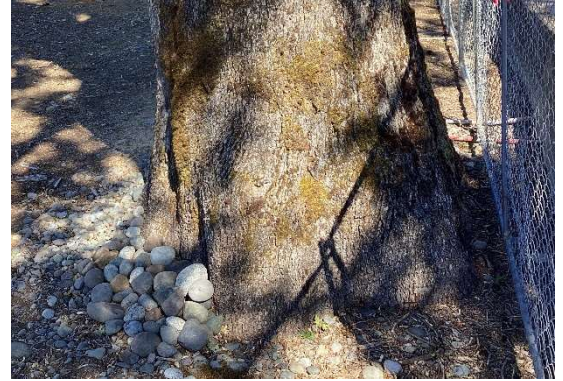
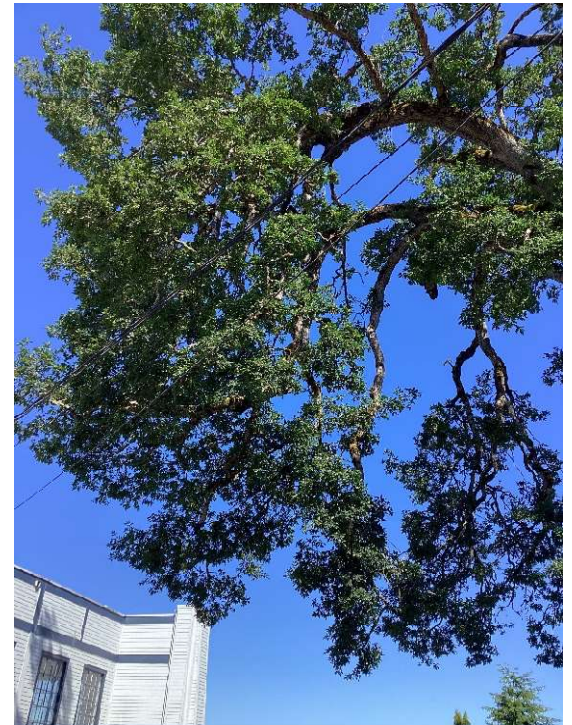
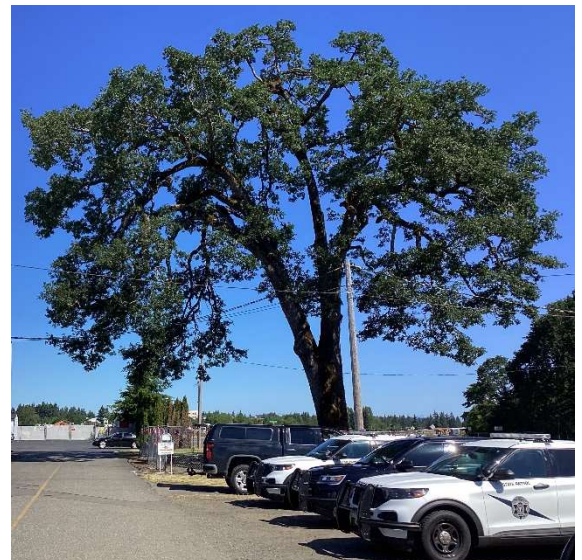
On my visit, I observed nesting birds. The nest is in a cavity roughly halfway up one of the main stems, which is a good indicator of the presence of decay.

The pre-mitigation risk rating per the basic risk assessment is **moderate**. My observations and previous arborist evaluations have noted decay is present in at least parts of the lower 2/3 of the woody portions of the tree. That decay is the main condition of concern in all the reports. Determining the extent of decay in the upper woody parts is difficult. Before applying the recommended mitigation efforts, I highly recommend an additional aerial/climbing inspection by an arborist familiar with ancient oak trees—specifically White Oaks. One such arborist I recommend, who has over 40 years of experience and is still climbing and working on big old Oaks, is Casey P. Roland of Roland Tree Care in Medford, Oregon. That inspection may change the risk rating and would likely provide information to help choose a mitigation option better. An aerial drone inspection would not be sufficient.

3. Remove all the rocks up against or touching the root crown. This will allow a critical and vulnerable area where woody roots join the stem to completely dry out and not hold moisture, making it easier for pathogens to enter.

4. Selective pruning to remove deadwood greater than 1" in diameter and any limbs in active failure. This action alone will move one part of the risk rating (from Matrix 2) from **moderate to low**.

5. Selective pruning for weight reduction in the lower 2/3 of large scaffolding branches. No cuts should be over 3" in diameter and, when possible, made from parts beneath the larger limbs. No pruning or topping of any "green" limbs in the top 1/3 of the tree crown should be made. No more than 10% to 15% of the healthy "green" limbs in the entire crown should be removed during the pruning operation. This will reduce some weight in the decayed or over-extended limbs. All pruning should be done by or under the supervision of an ISA Certified Arborist to ANSI Z-133 requirements and industry best practices.

6. Install a support system, such as a dynamic cable system, per ANSI Z-133 Safety Requirements and ISA best practices and standards. This action will reduce load pressure on codominant and decayed limbs, moving the other risk rating (from Matrix 2) from **moderate to low** and ultimately reducing this tree's overall residual risk rating to **low**.  
*\* The recommended aerial inspection can determine the cable system's feasibility, type, and location.*

7. Restrict pedestrian access beneath the tree and move parking away from the dripline to 1.5 times the tree's height or as far as possible. This will eliminate or reduce the target occupancy rate.

Monitor and inspect the tree at least every two years. Prune as needed. Inspect and adjust the cable system at least every three years. Maintain wood chip mulch in the root zone.
